## *Post-Disaster Restoration and Revitalization Concept for the Souraja Traditional House Area, Palu City*

## Konsep Pemulihan dan Revitalisasi Pasca Bencana untuk Kawasan Rumah Tradisional Souraja, Kota Palu

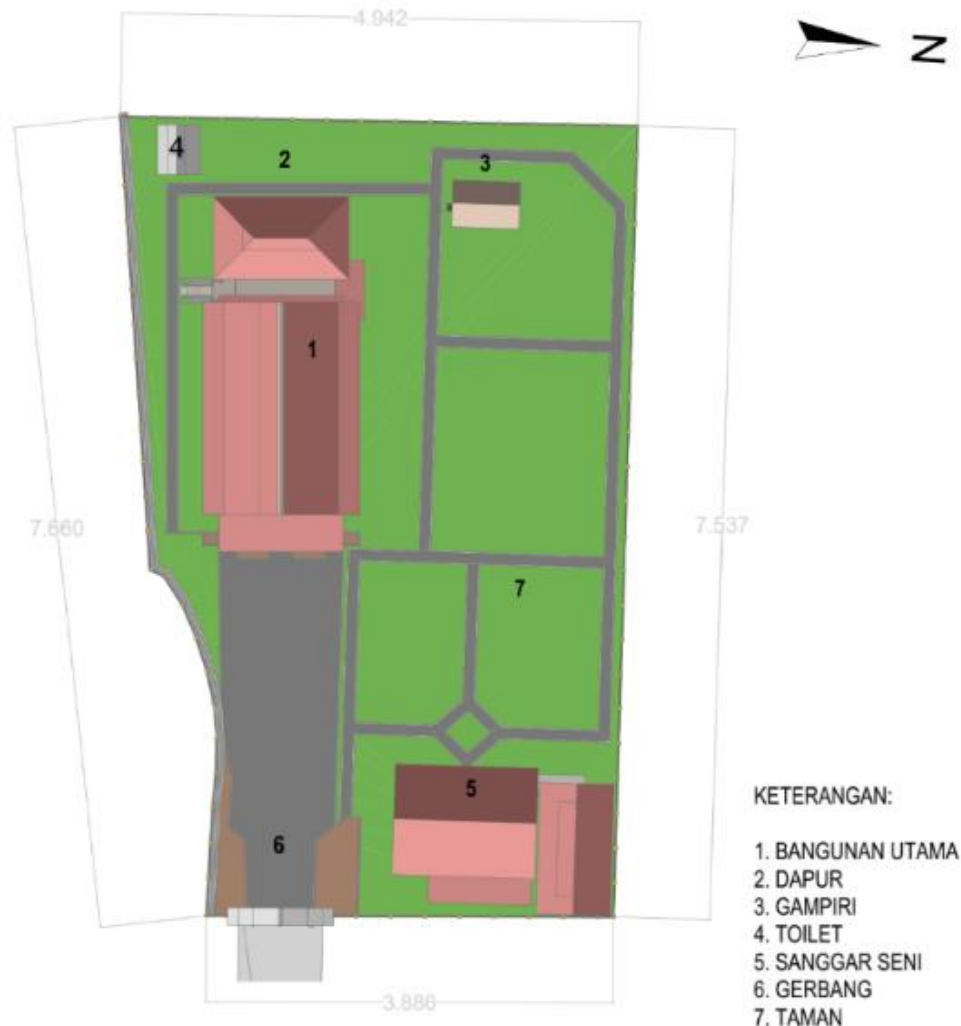
**Figure 2.** Site Plan of Souraja Cultural Heritage Area.

The total area of the Souraja heritage site is 3,724 m<sup>2</sup>, based on field measurements verified using architectural documentation provided by the Cultural Heritage Preservation Center (BPK Wilayah XVIII). The heritage complex comprises several supporting facilities in addition to the main Souraja Traditional House, including an art studio, public toilets, perimeter fencing, entrance gates, landscaped gardens, and parking areas that support visitor activities. Another important structure within the complex is the Gampiri, a traditional stilt building used as a rice granary. Architecturally, the Gampiri is characterized by its elongated rectangular form, simple design, and absence of windows, reflecting its primary function as a storage facility for harvested rice. The spatial arrangement of the heritage complex, including the location of the Souraja Traditional House, supporting facilities, and Gampiri, is illustrated in Figure 2.

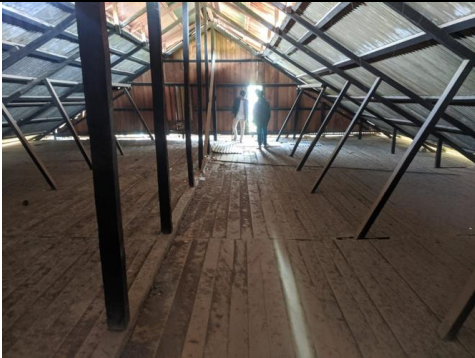
| Table 3. Building Structure | | |
|---|---|---|
| Upper structure | | Upper Structure: Number of trusses 11 pieces. |

The structural configuration of the Souraja Traditional House was documented through direct field measurements and verified using architectural drawings and technical documentation provided by the Cultural Heritage Preservation Center (BPK Wilayah XVIII). Field measurements indicate that the building has an overall dimension of 32.0 m in length and 11.5 m in width. The lower structural system consists of nine entrance steps, 28 primary timber columns, and eight kitchen-support columns, all identified during the field survey and confirmed through existing architectural documentation. The middle structural system comprises the principal load-bearing columns supporting the main house and front terrace, while the upper structural system is formed by 11 timber roof trusses supporting the roof structure. The detailed structural characteristics and their corresponding data sources are presented in Table 3.

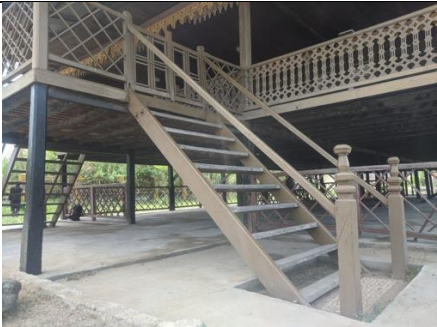
| Super structure | | Mid Structure: The number of columns for the main house and terrace is 28. |

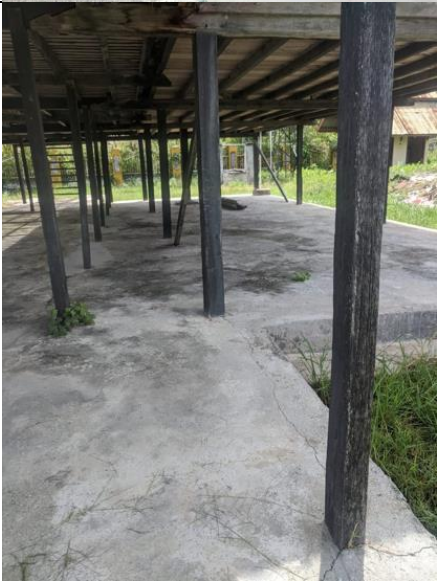
| Sub structure | | Substructure: Number of steps 9, Number of pillars of the main house 28, Number of pillars of the kitchen house 8 with <i>Umpak</i> foundation. |

The first priority focuses on the lower structural system, including the pedestal foundations and timber columns. Field observations indicated that the building has experienced a differential inclination of approximately 10–15 cm, suggesting uneven structural settlement following repeated seismic events. Previous rehabilitation works replaced parts of the original pedestal foundation with cast concrete flooring, reducing the flexibility of the traditional foundation system. Considering the seismic characteristics of the Palu region, it is recommended that the pedestal foundation concept be reinstated to improve structural adaptability during future earthquakes. Additional reinforcement using ironwood supports or steel pipe bracing is proposed to stabilize the existing timber columns while minimizing intervention to the original structure. Stage 2 – Rehabilitation of the Floor Structure.
